1428 S 6th Our property

Ours is the best property on the block. A statement that the inspector concurred with.

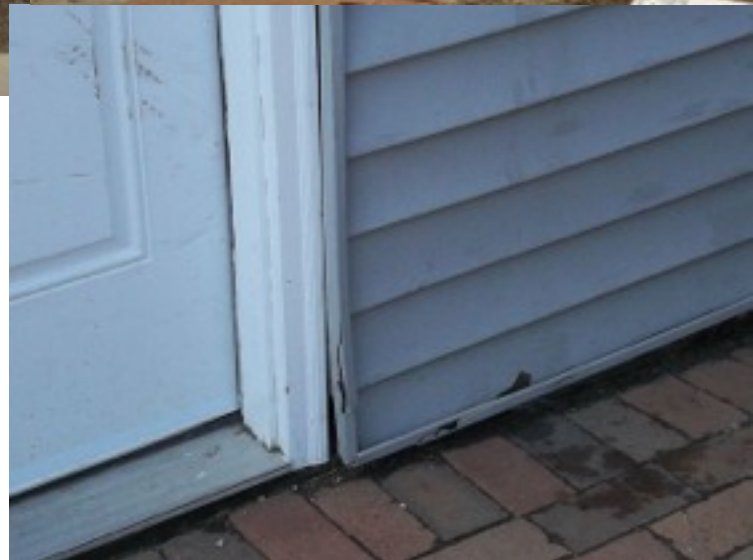
This is the inspector's definition of "defective siding"

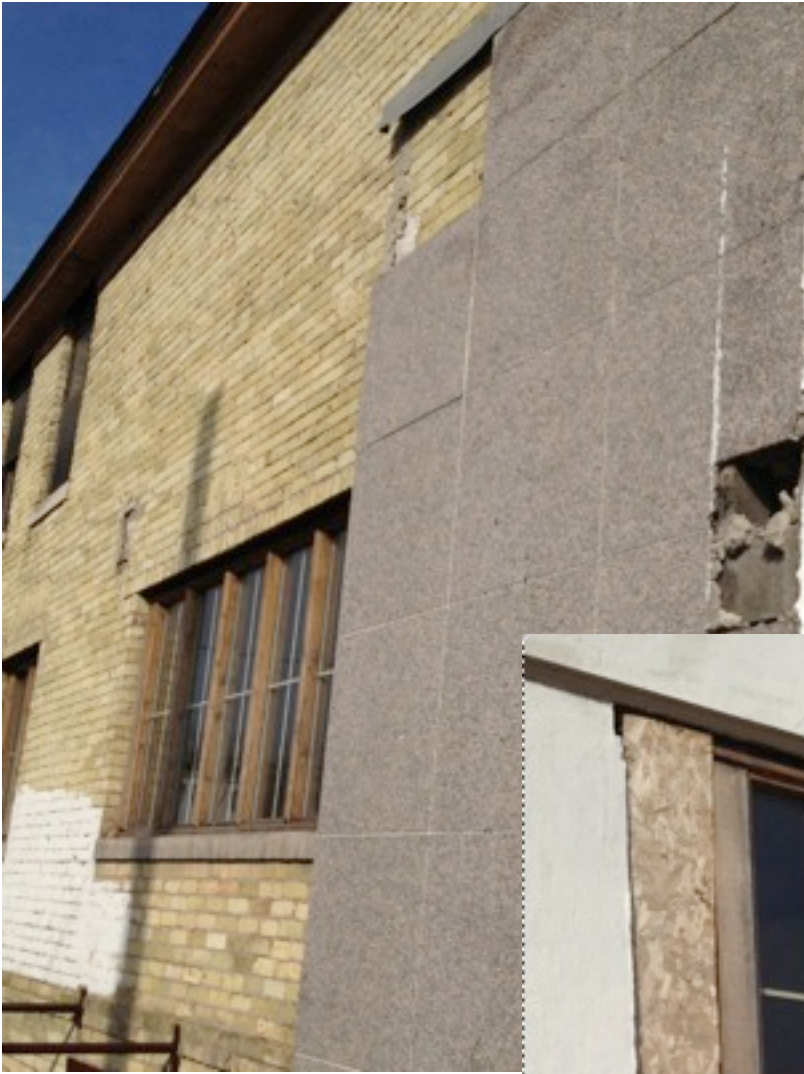
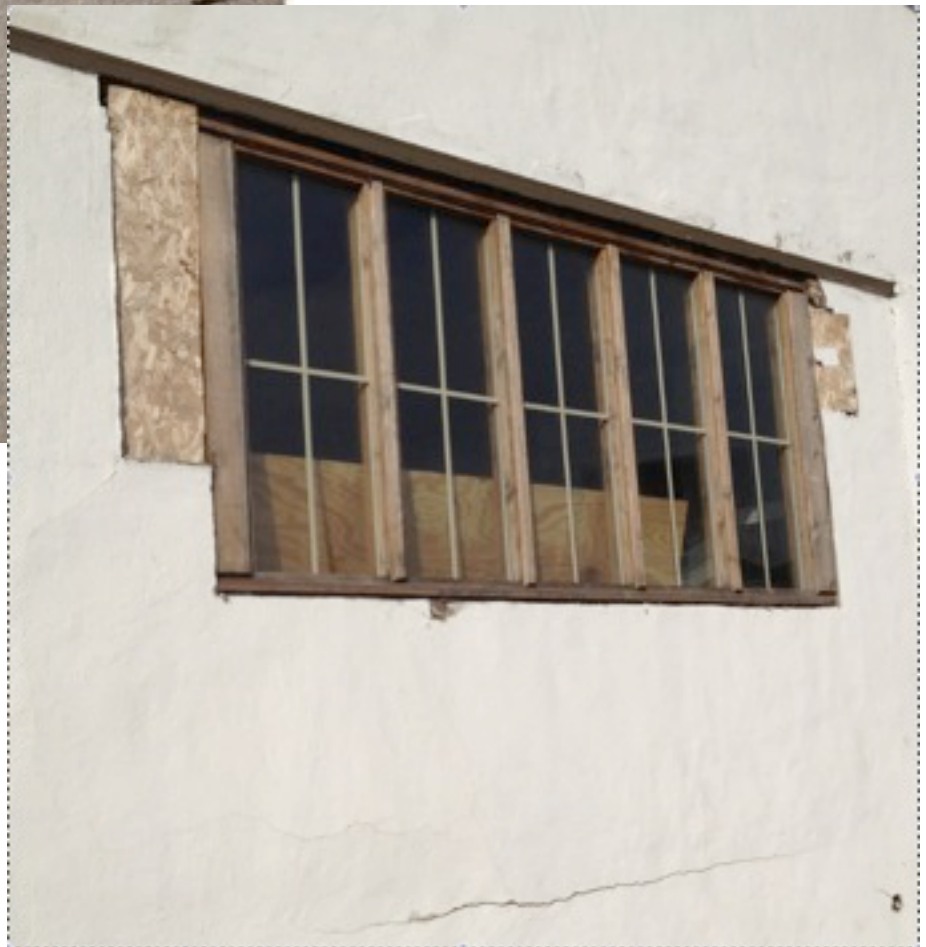
1401 S 6th. Missing panel on south side of building.

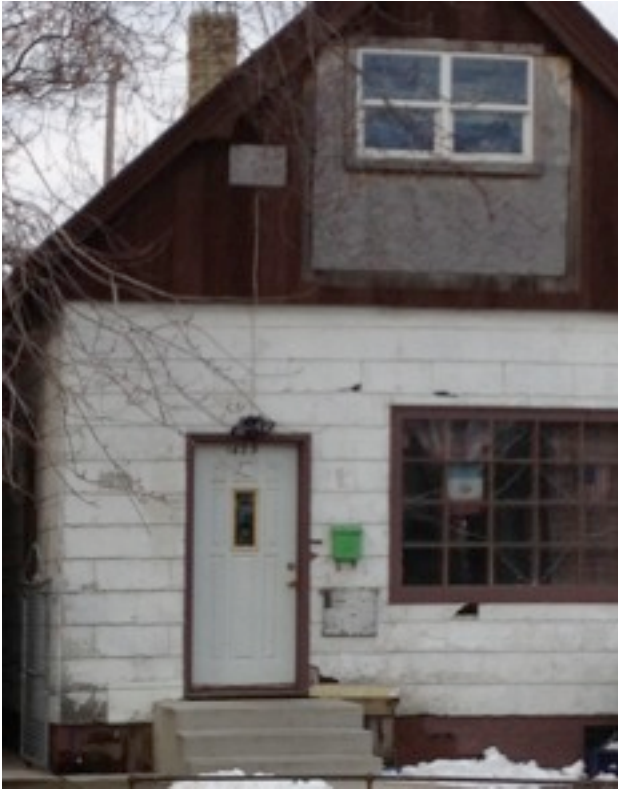
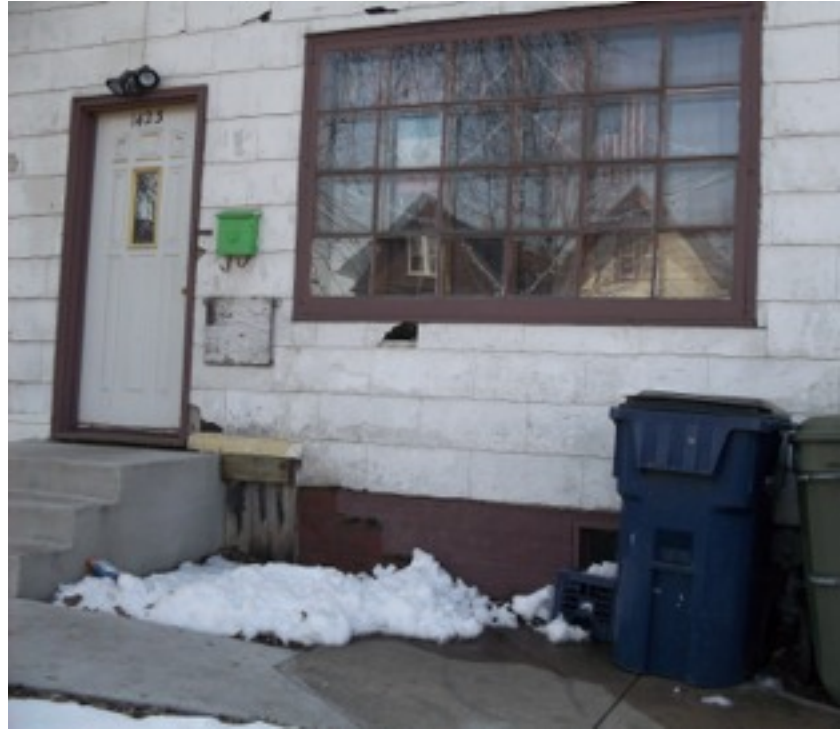
1423 S 6th. (across 1 house north) Defective/missing siding, window changed without permit, needs paint, no rails.

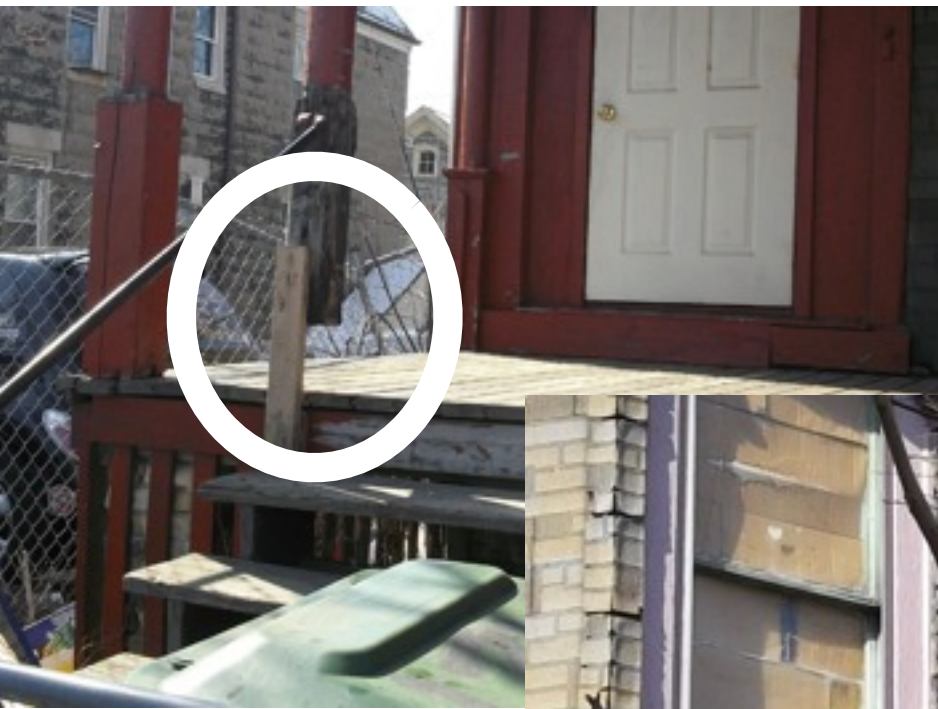
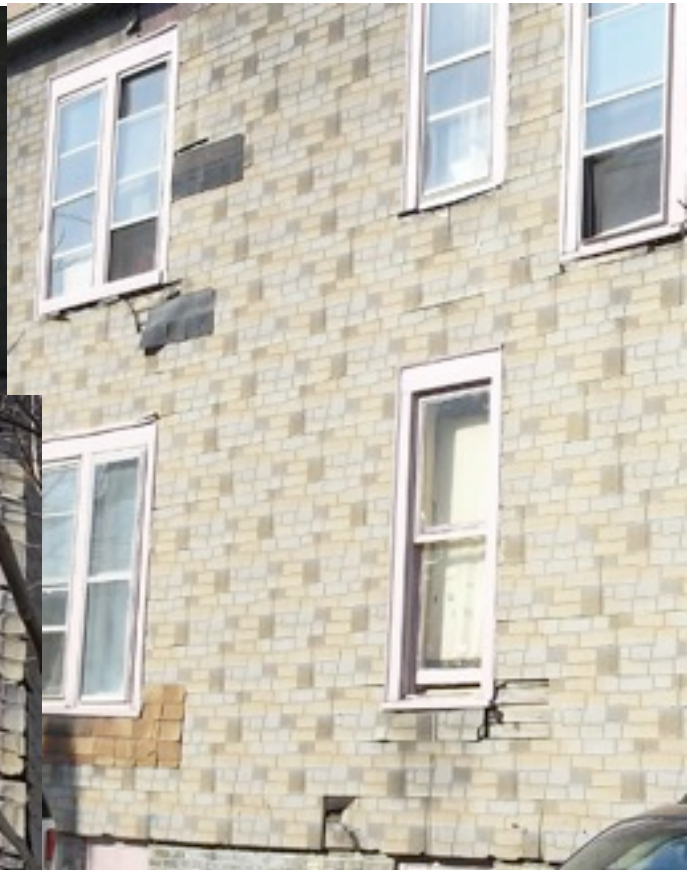
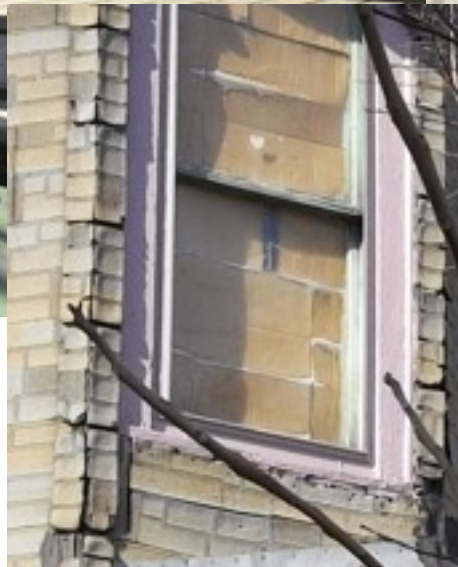
1427 S 6th (Directly across) Needs roofing, siding, rails, porch paint. broken windows, needs paint and you gotta love the anti gravitational porch support

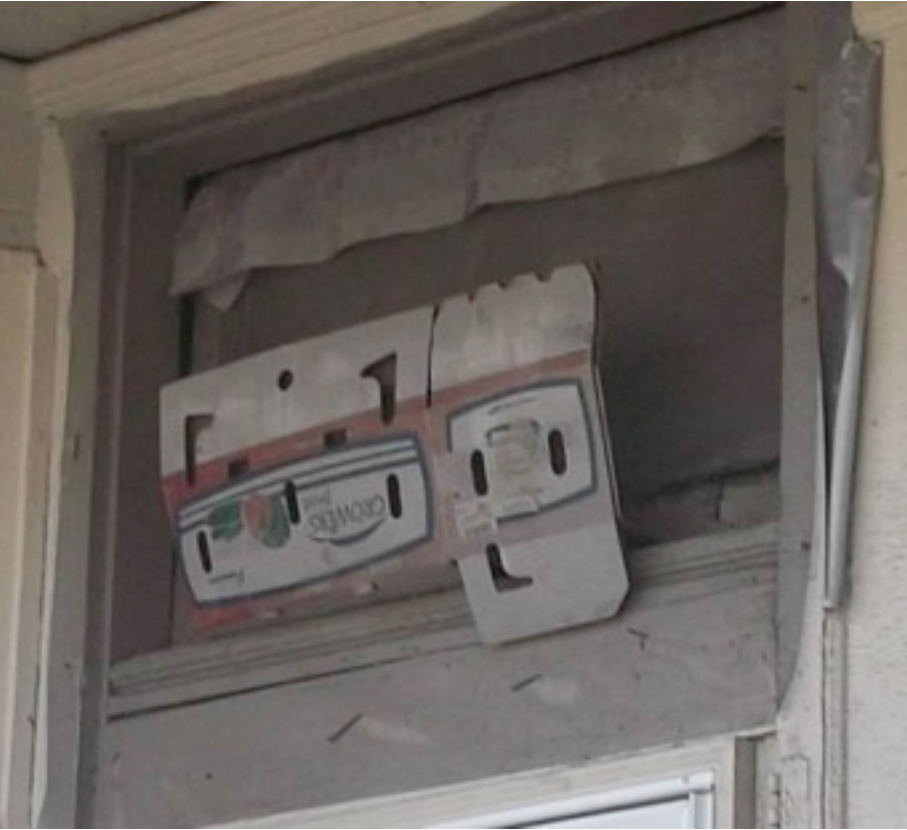
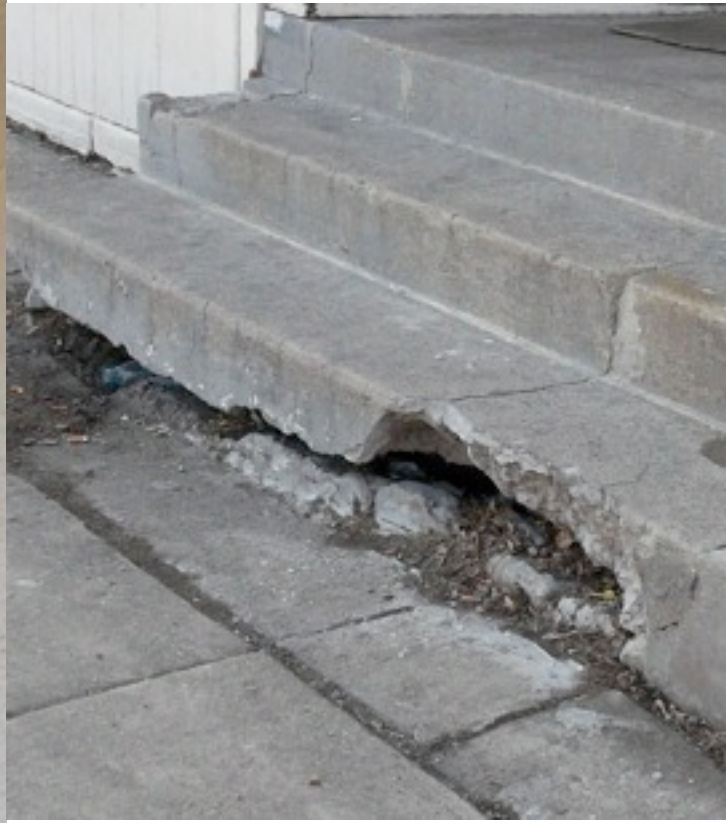
1433 S 6th (Across street 1 door south)

needs front porch work

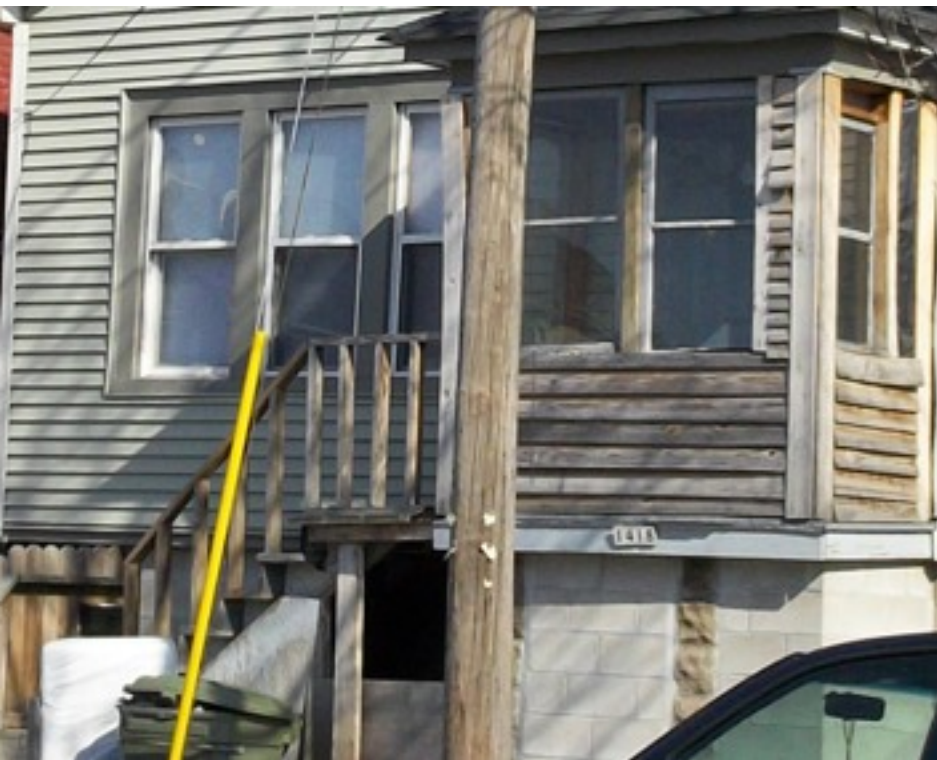
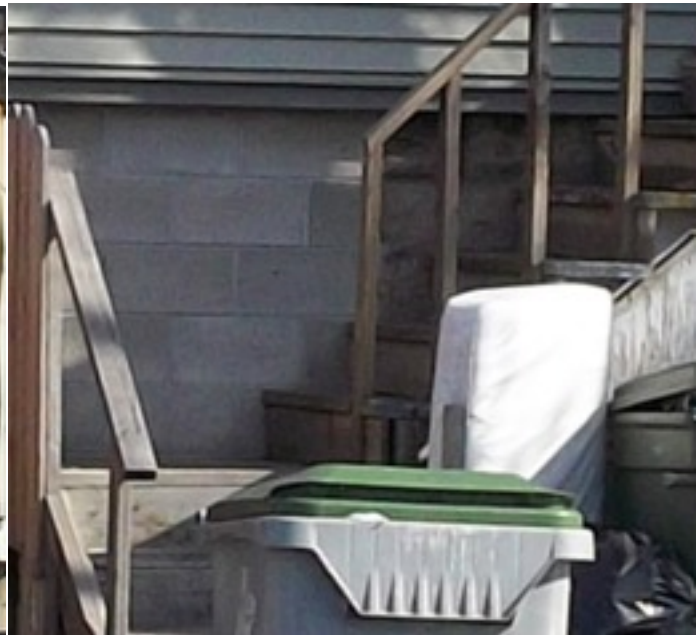
1418 S 6th 3 doors north Needs paint. Rails, siding

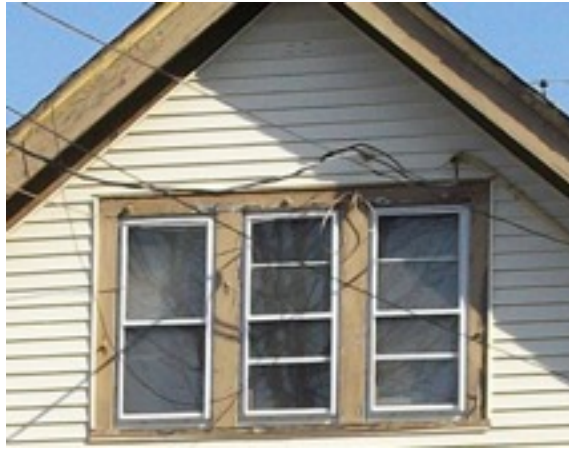
**1420 S 6th** 2 doors north  
Needs paint

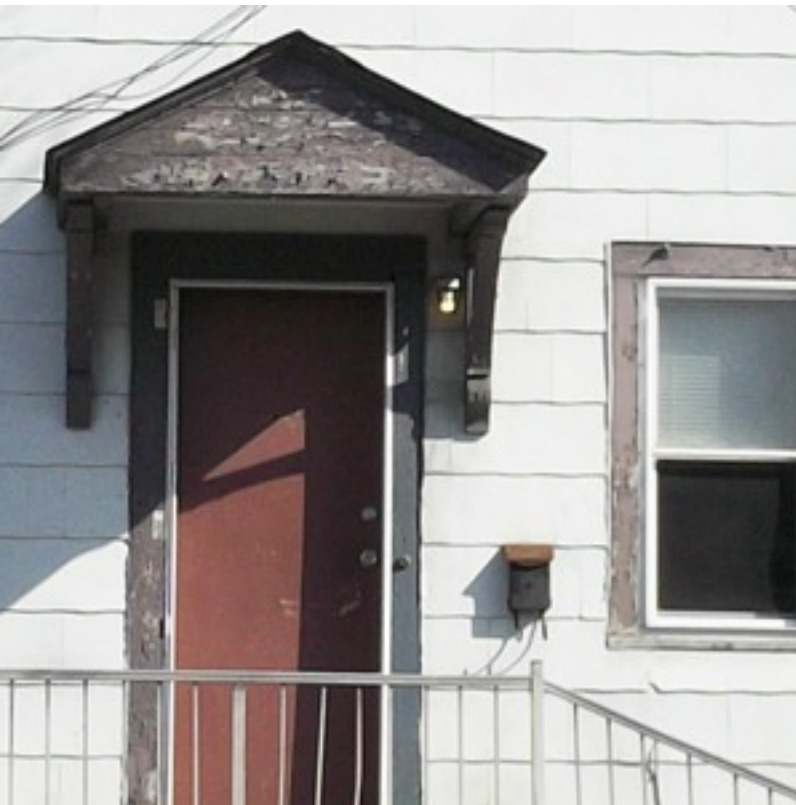
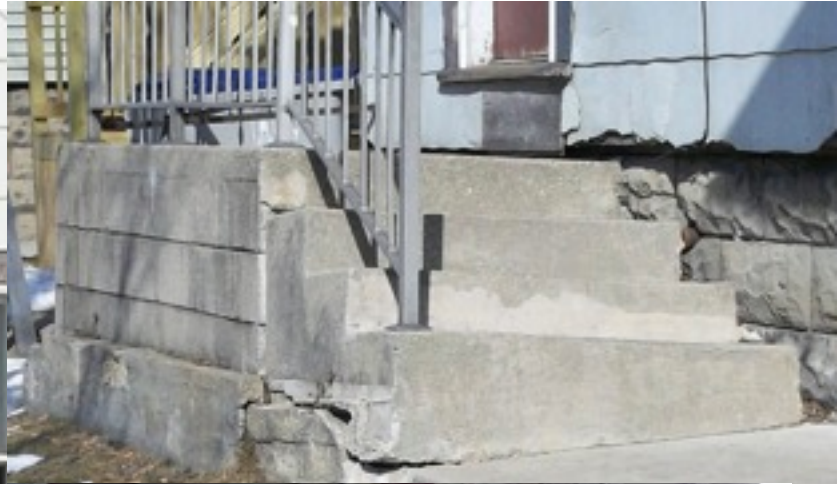
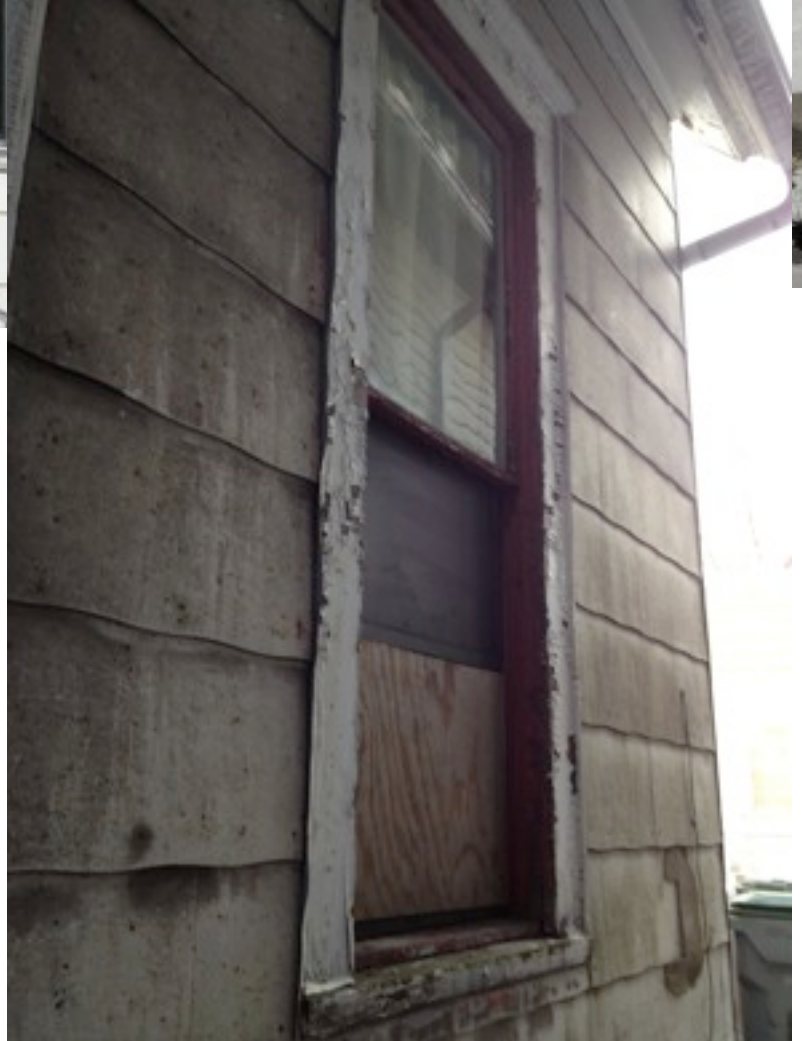
**1424 S 6th** Adjoining North Missing siding, needs paint, defective front steps needs paint, siding, front step is defective, sidewalk is defective.

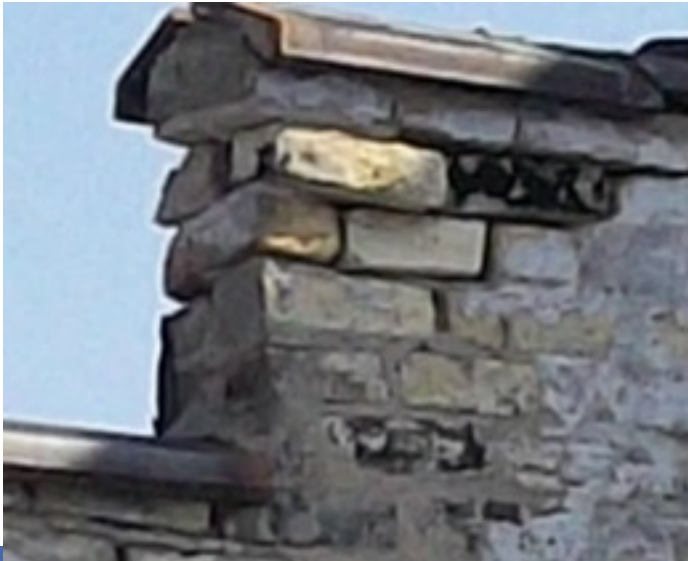
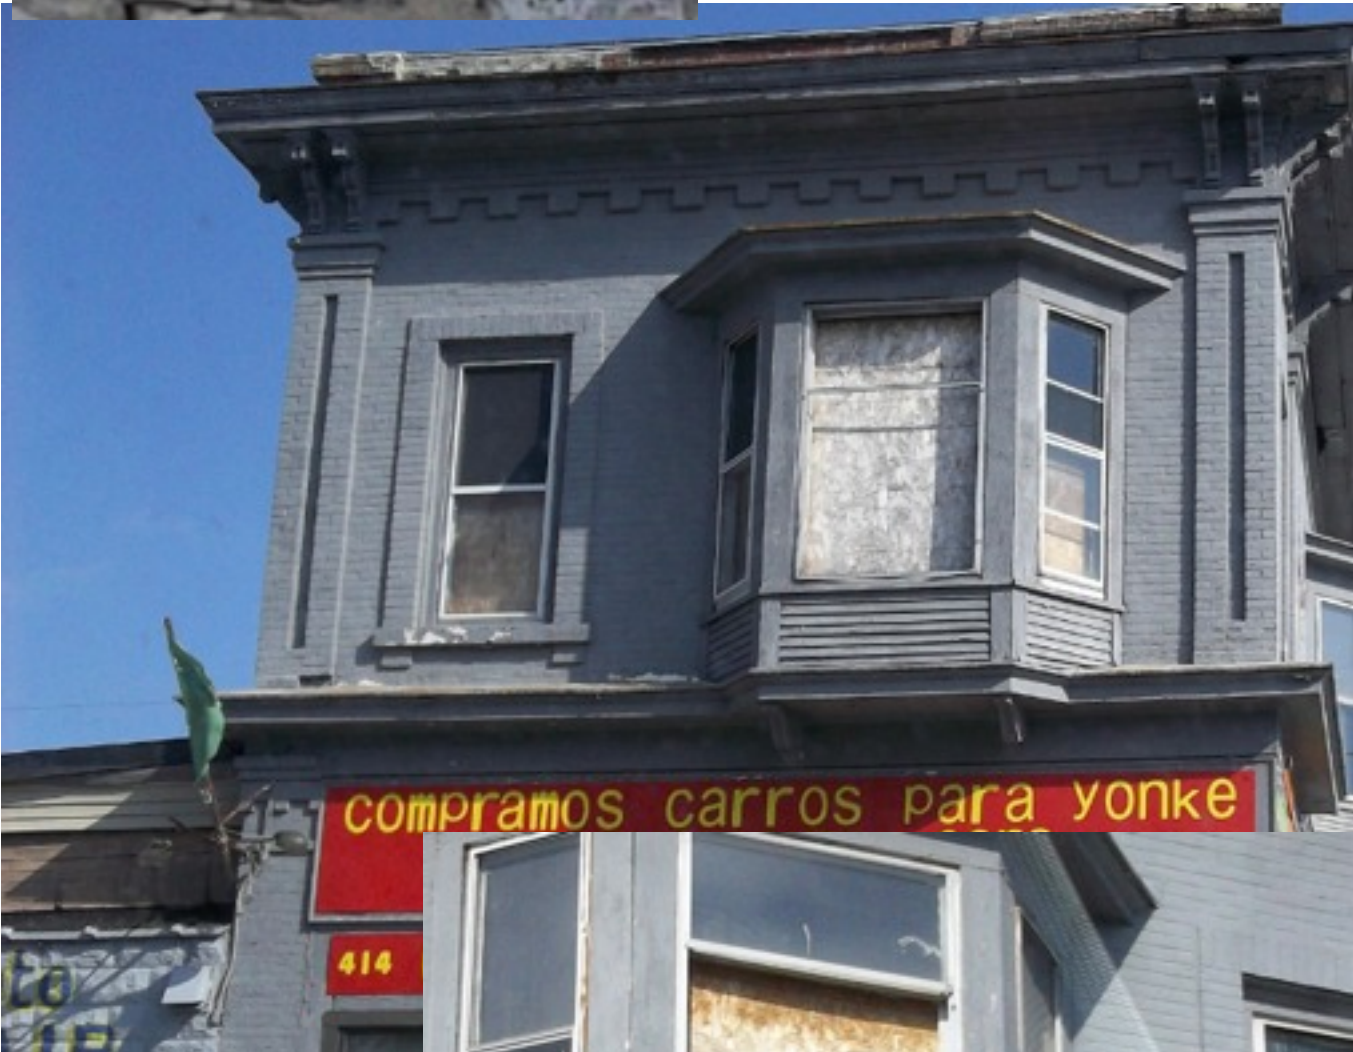
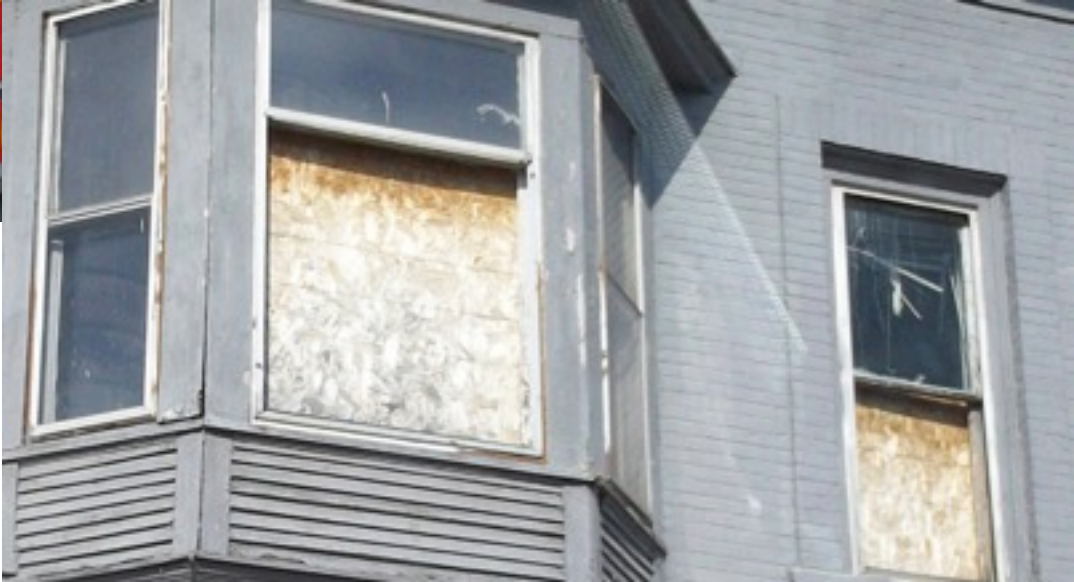
1438 S 6th Adjoining South. Missing windows, failing parapet wall missing siding etc.
